REDESIGN AND CREATION OF THE CROCKING MACHINE FABRIC LOCK FOR MORE ACCURATE CROCKING

Reza Tripratama Budiono¹⁾, Puji Basuki^{2)*}

1)2)Teknik Mesin Fakultas Teknik Universitas Pandanaran

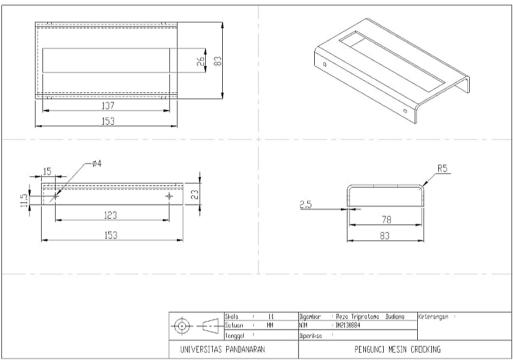
Figure 3 Lock Modification

The fabric locker design was carried out to address the main problem with crocking machines, namely the fabric still moving during operation due to insufficient position and number of locking points. The first step was to analyze the existing fabric locker design, followed by identifying the existing problems. The new fabric locker design, as shown in Figure 3, allows for the creation of technical drawings with a high degree of accuracy and precision.

The locking component design was created in 2D and 3D to facilitate visualization and accurate dimensional calculations. Several factors were considered in this design, including material strength, ease of maintenance, and space efficiency on the machine. The locking components, including the locking mechanism, support, and pressure regulator, were designed with resistance to friction and wear during machine use in mind.

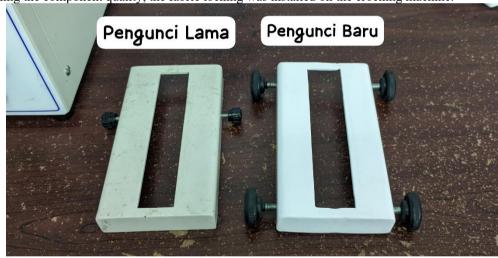
Figure 5: Comparison of the old and new locking system.

After the fabric locking design was completed, the manufacturing phase was carried out, taking into account the established specifications. This involved increasing the number of locking bolts from the previous 2 to 4 (Figure 5). The fabric locking was manufactured according to the design validated during the design phase. The manufacturing results demonstrated that the locking components could be accurately manufactured to the specified dimensions. The fabrication process used materials selected for their strength against friction and wear resistance. After checking the component quality, the fabric locking was installed on the crocking machine.

Installation: The old lock only had two bolts, resulting in only two locking points, while the new lock has four locking points, allowing for adjustable fabric tension.

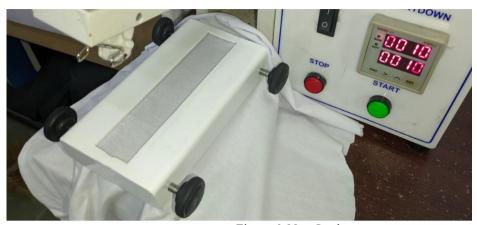
Figure 6. New Lock

After the modified fabric locking system in Figure 6 was tested during machine operation, meeting the applicable standard of 10 strokes. The results of the operational trials on 24s combed cotton fabric showed that the new fabric locking system could smoothly withstand 10 strokes without any ripples appearing. Meanwhile, the old fabric locking system showed ripples appearing on the second stroke, and by the 10th stroke, the ripples had worsened.

By using the modified lock, the machine can operate more efficiently without unwanted fabric movement. The fabric remains still and stable throughout the entire machine operation. The new fabric lock securely locks the fabric, ensuring that it doesn't move or shift, which often occurs with the old lock design. This not only improves product quality but also reduces the possibility of fabric damage due to uncontrolled movement.
